ASHUELOT POND DAM

NH 00237

PHASE I INSPECTION REPORT NATIONAL DAM INSPECTION PROGRAM

JUNE 1979

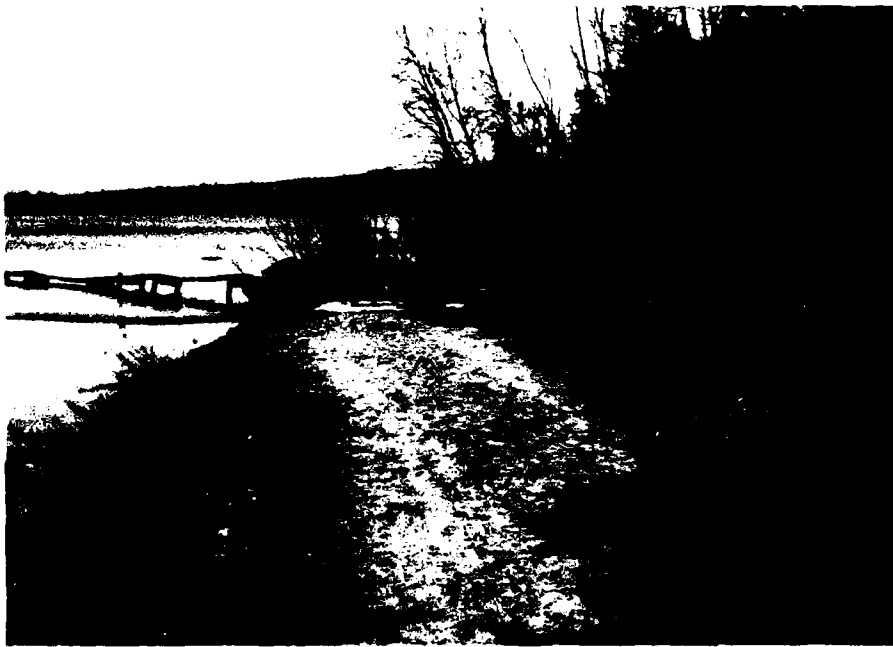
Several areas of the crest are barren, as shown in Photos No. 4 and 5. This erosion has probably been caused by trespassing on the crest. Several trees were observed on the crest, and the roots of trees were observed protruding through the surface of the crest near the left side of the dam, as shown in Photo No. 5.

PHOTO NO. 4 - View of dam crest from right abutment.

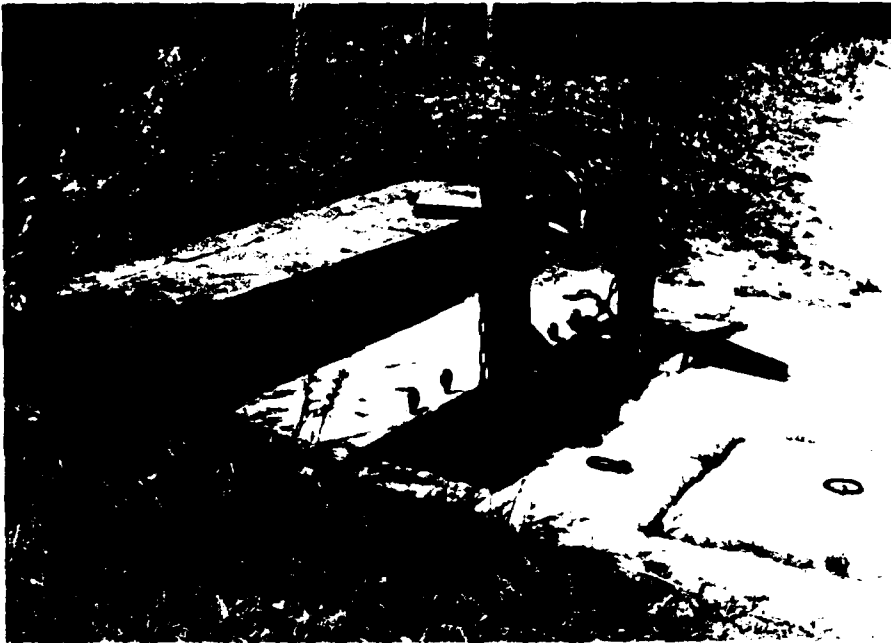
The stoplogs appear to be in good condition. The gates and trash rack were not inspected as they were below water. The gate stems are rusted and the gates were inoperable, see Photo No. 8. The manhole at the outlet works did not allow for vertical access to the stoplogs.

PHOTO NO. 8 - View of gate operating mechanizm.

(e) Repair the outlet works gates such that they can be operated.
